HDPE or PVC

ONE DESIGNERS PERSPECTIVE

HDPE – WHERE, WHY, AND WHY NOT

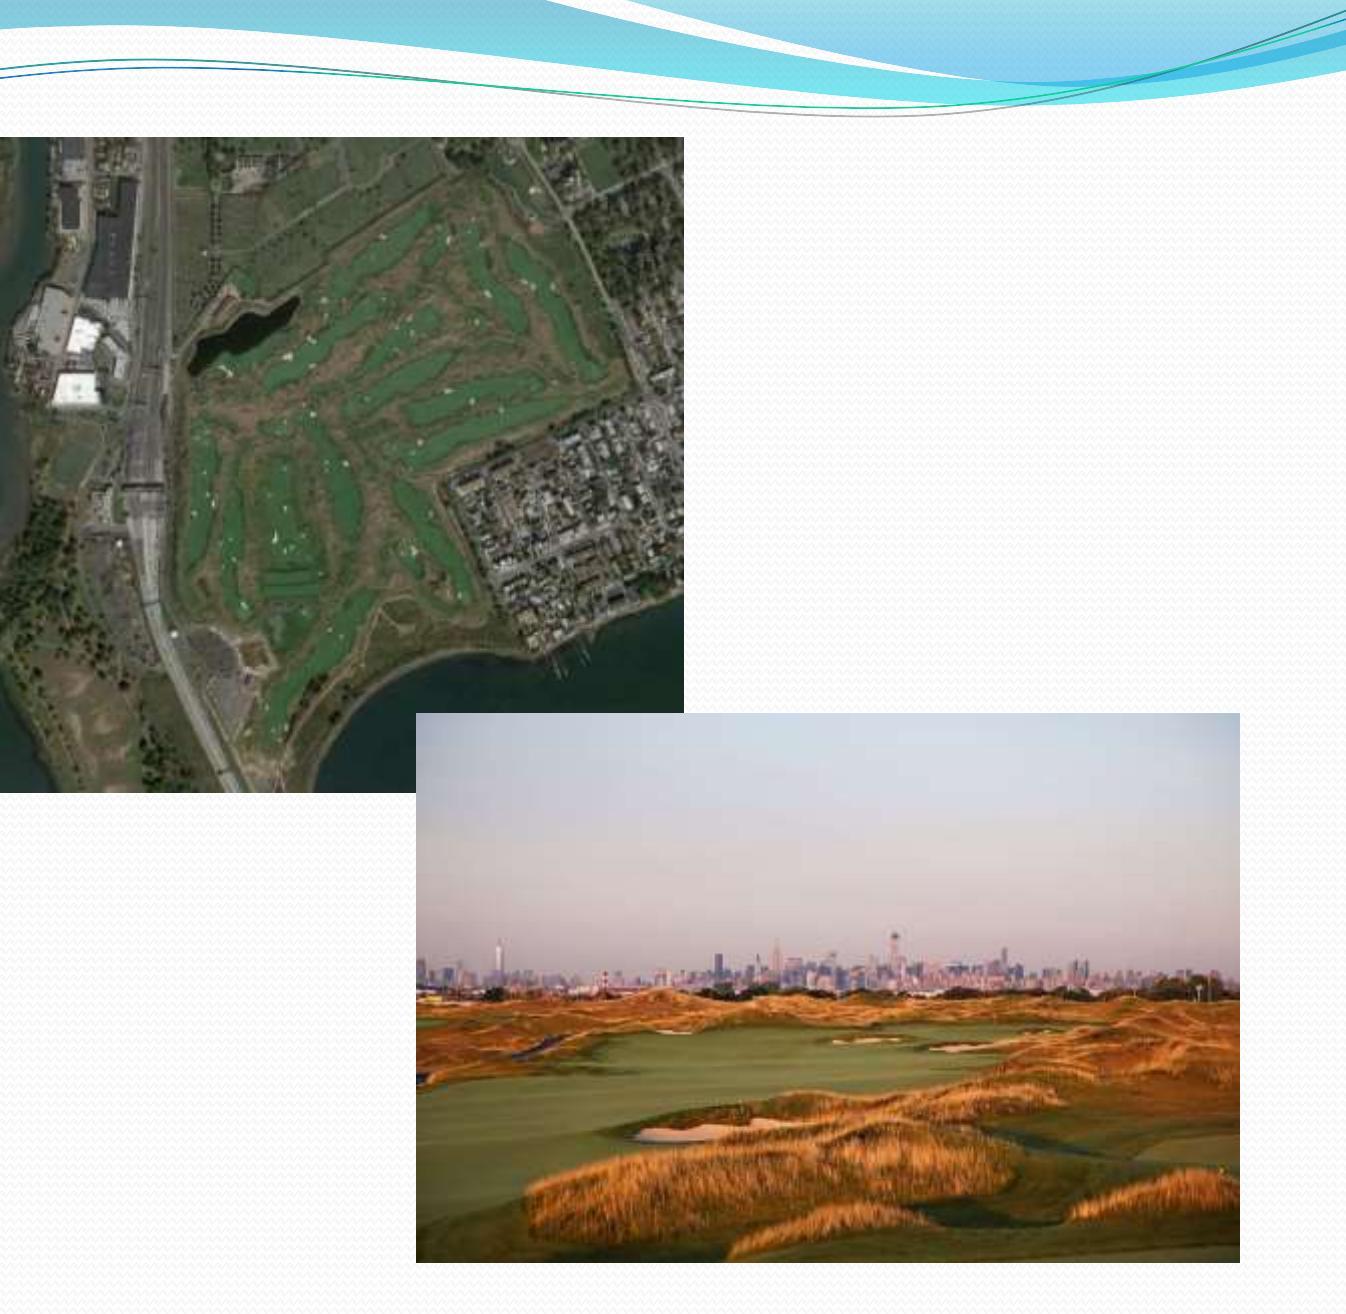
TRUMP LINKS – FERRY POINT

• Shifting soils (landfills/slopes/sand)

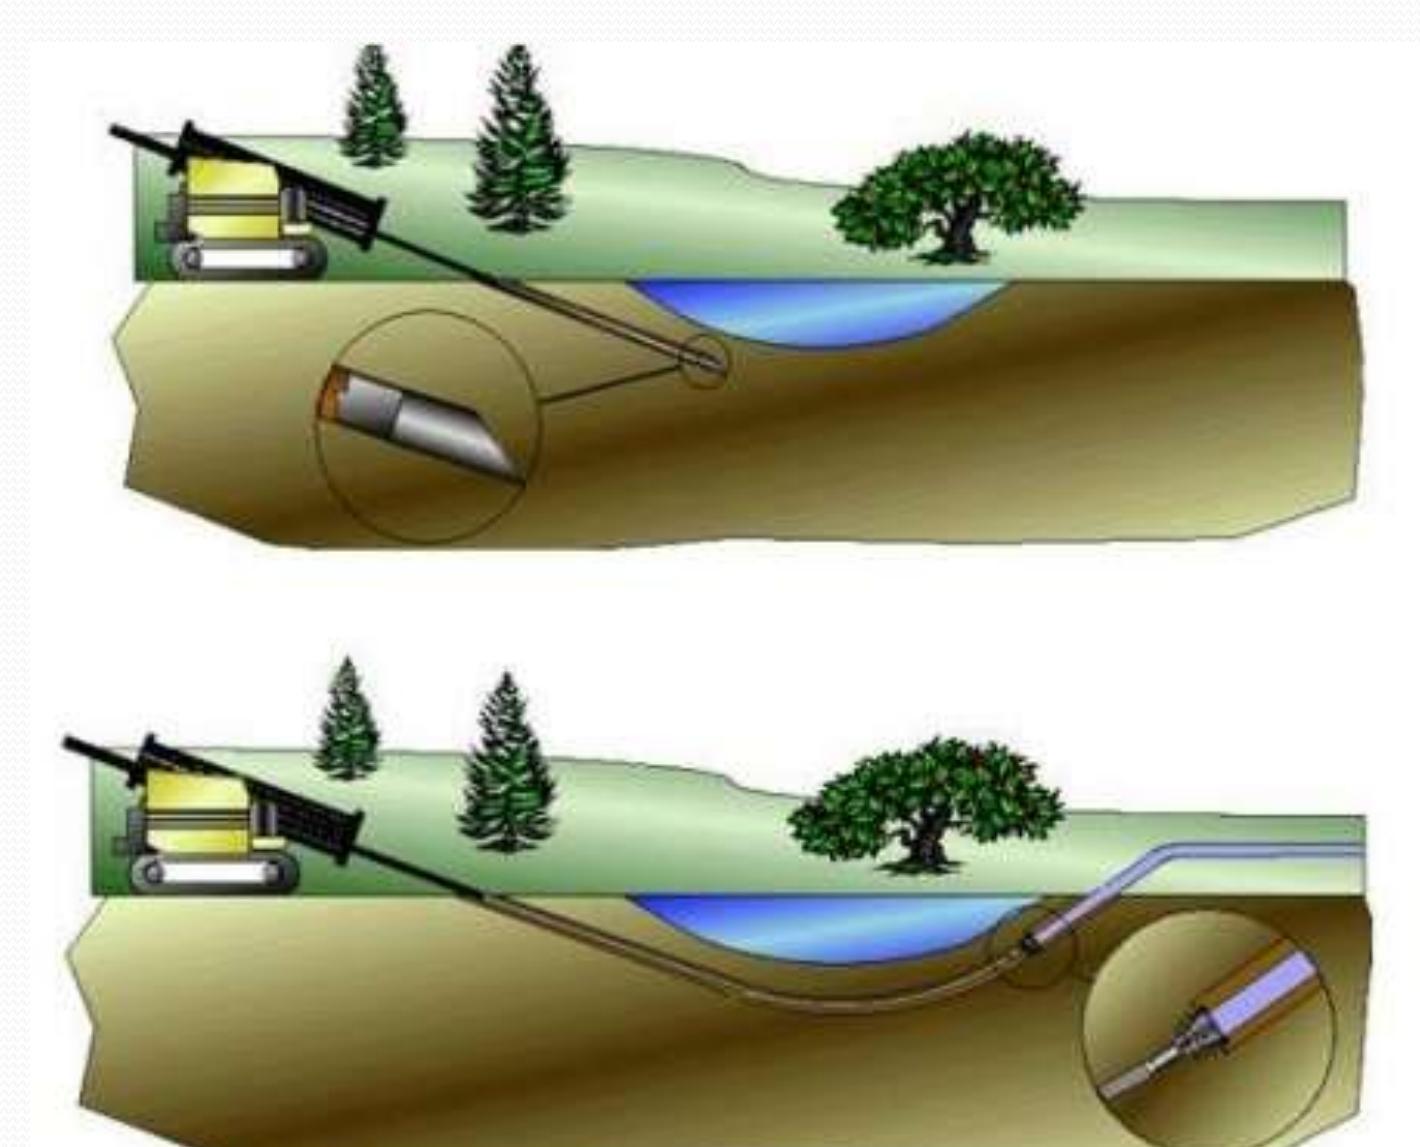
- Shifting soils (landfills/slopes)
- Corrosive soils (DI fittings?)
- Challenging terrain
- Directional boring

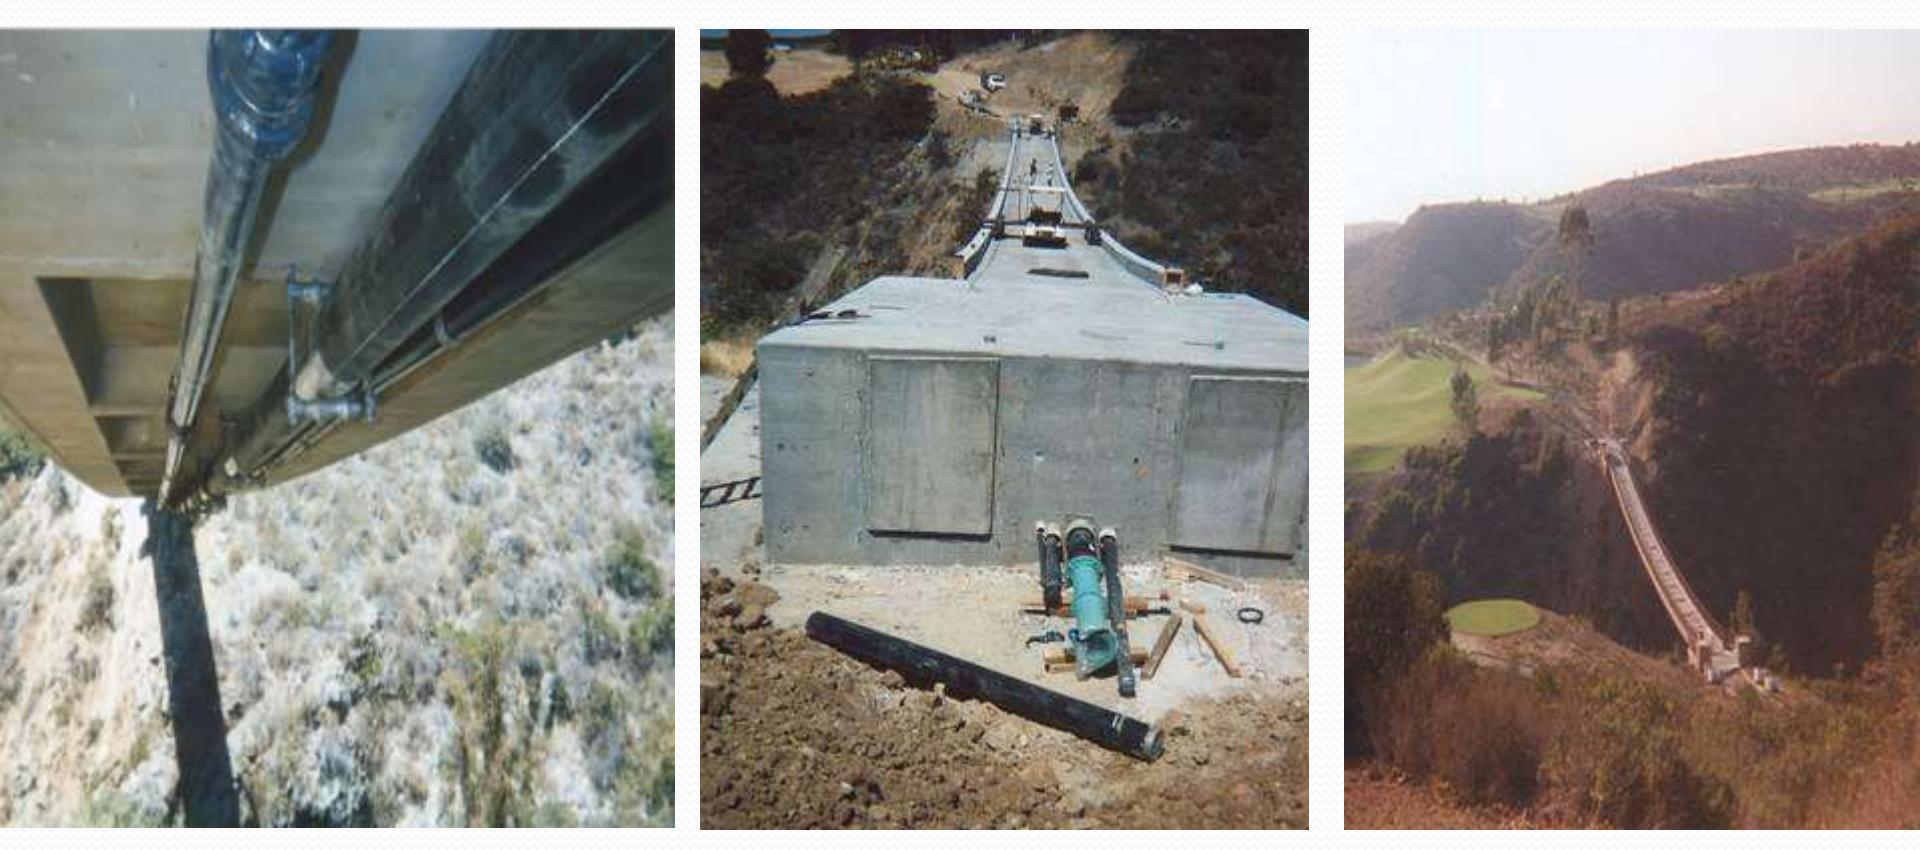
Certain bridge crossings

338' FROM END TO END

Example: 300' bridge in Las Vegas July: High temp = 115, Low temp = 80 HDPE: $1.2 \times 3.5 \times 3 = 12.6$ " PVC: .33 x 3.5 x 3 = 3.46" DI: .07 x 3.5 x 3 = 0.74"

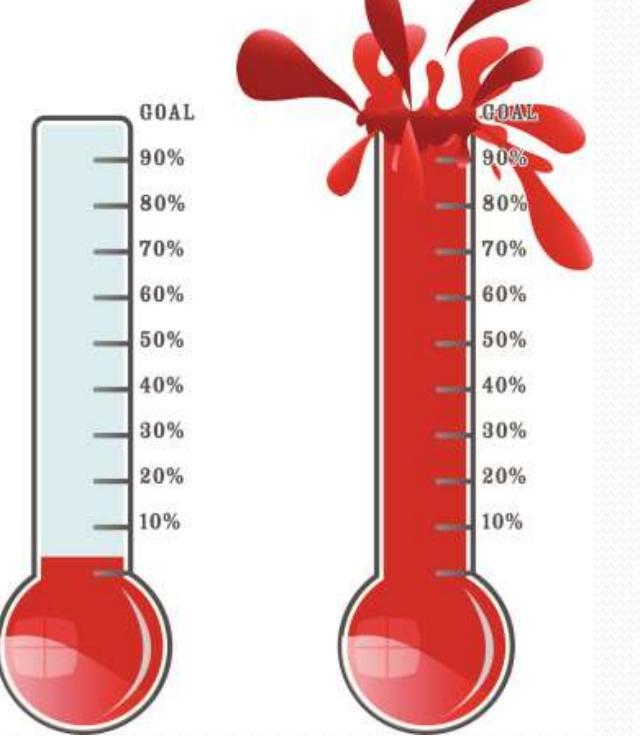
- Thermal Expansion of HDPE
- Pressure de-rate with temperature increase

- HDPE: 1.2" / 10 deg F / 100 ft
- PVC: 0.33" / 10 deg F/ 100 ft
- Ductile Iron: 0.07" / 10 deg F / 100 ft

- DERATE FOR TEMPERATURE (per PPI)
 - </=80 DEGREES = 1.0
 - 100 DEGREES = 0.78
 - 120 DEGREES = 0.73

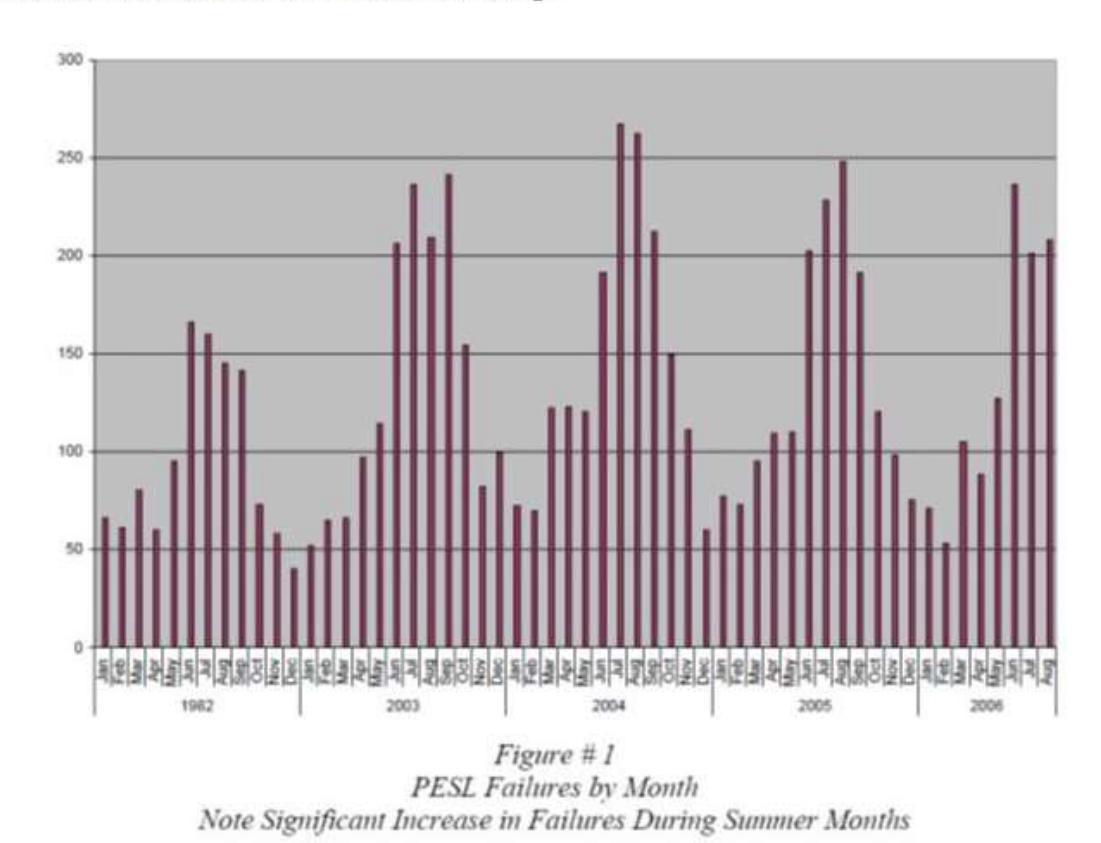
Las Vegas, NV; HDPE Service Line Failures:

Las Vegas Valley Water District (LVVWD) delivers water to over 1 million people in the Las Vegas Valley. Beginning in the early 1970's LVVWD began using polyethylene (HDPE) service laterals to deliver water from the mains to homes. In 1980, large numbers of HDPE service lines began to fail. Of the 80,000 HDPE service lines originally installed, about 56,000 are still in service, but the District is experiencing about 1500 failures per year.¹ One of the key causes of the failures as determined by LVVWD is oxidation of the HDPE service line which leads to brittle failure and cracking.²

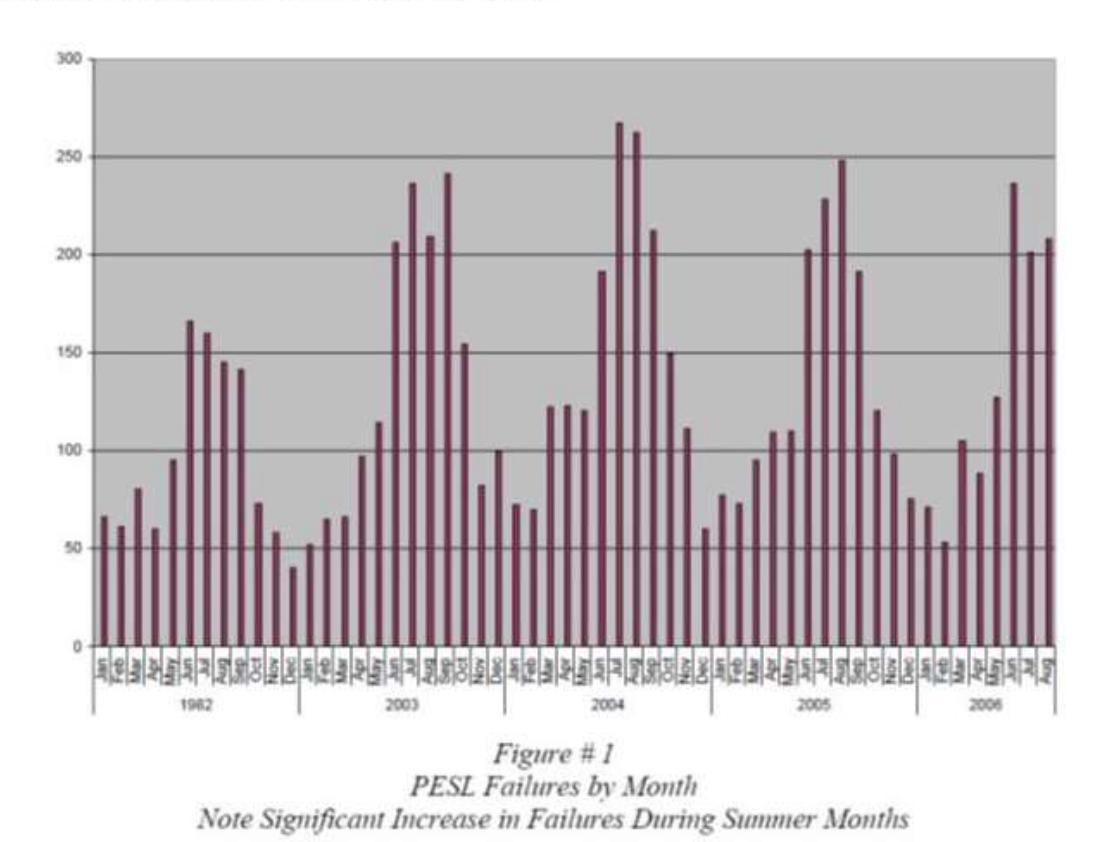
Las Vegas, NV; HDPE Service Line Failures:

Las Vegas Valley Water District (LVVWD) delivers water to over 1 million people in the Las Vegas Valley. Beginning in the early 1970's LVVWD began using polyethylene (HDPE) service laterals to deliver water from the mains to homes. In 1980, large numbers of HDPE service lines began to fail. Of the 80,000 HDPE service lines originally installed, about 56,000 are still in service, but the District is experiencing about 1500 failures per year.¹ One of the key causes of the failures as determined by LVVWD is oxidation of the HDPE service line which leads to brittle failure and cracking.²
